# **We Need Relief from Flooding Now**

## **Testimony by Kelley Williams**

Chair, Bigger Pie Forum  
Before The Mississippi River Commission. Greenville, Mississippi  
April 18, 2018

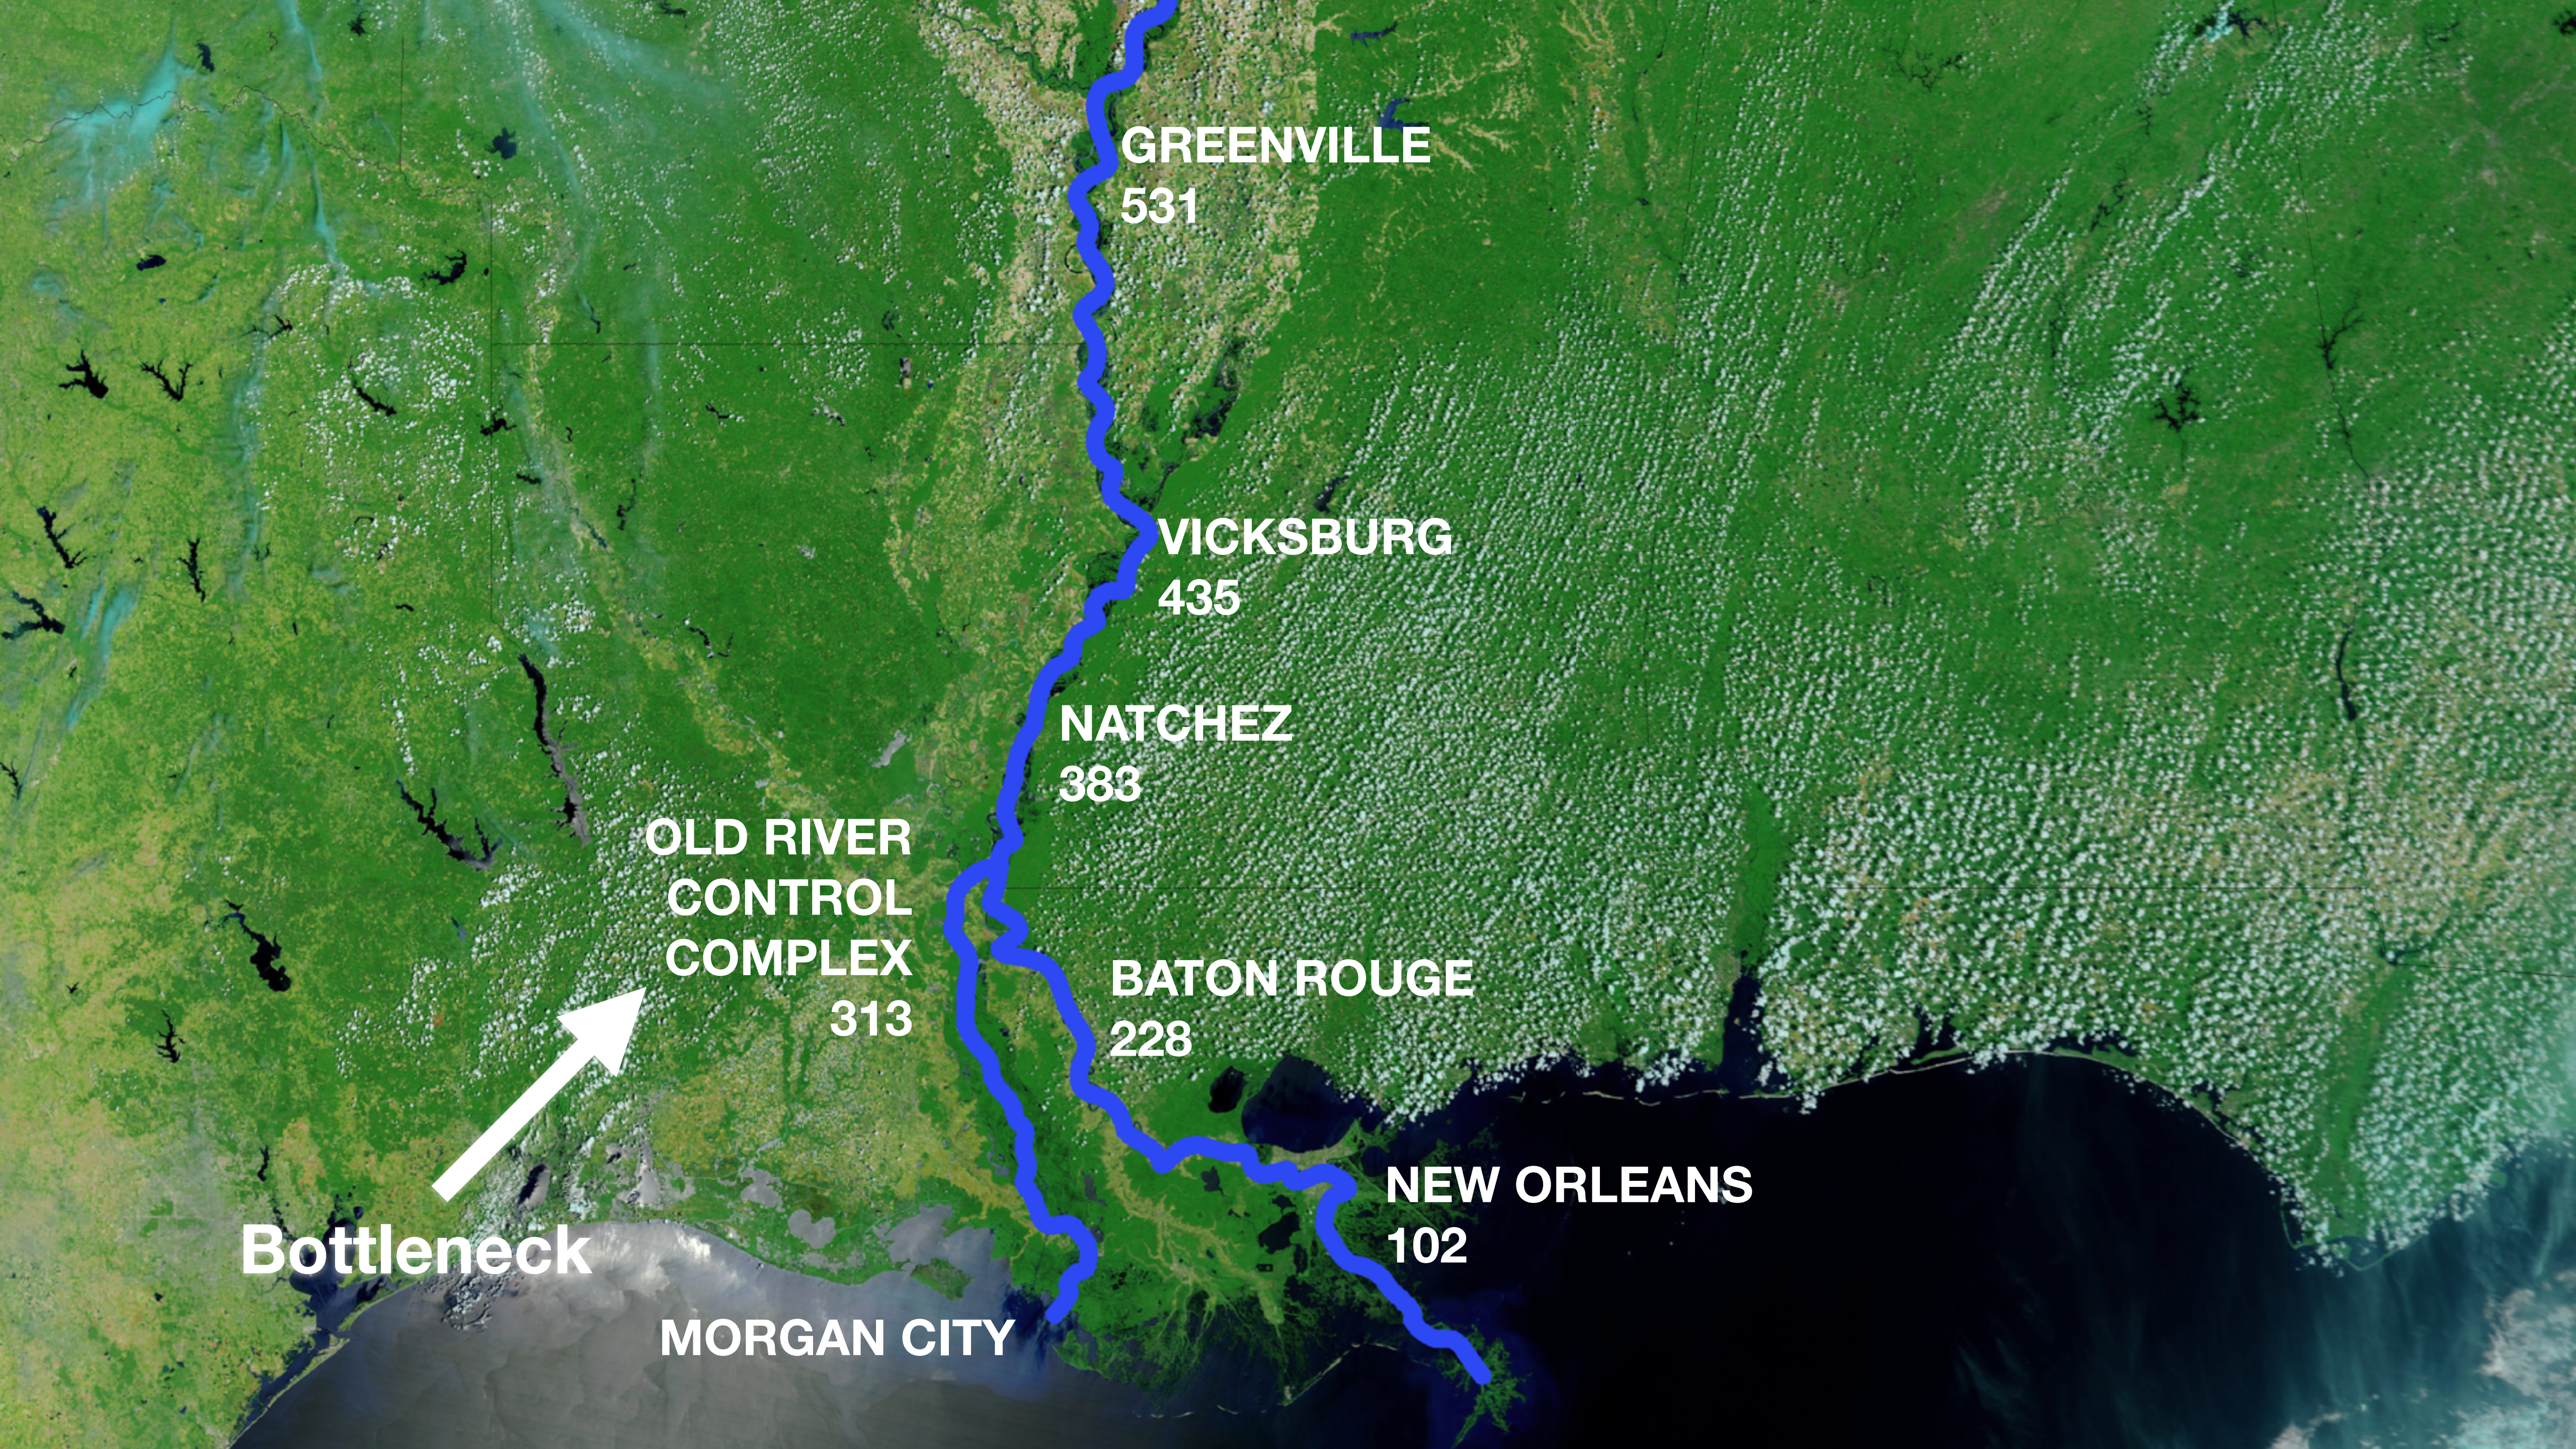
**GREENVILLE**  
531

**VICKSBURG**  
435

**NATCHEZ**  
383

**OLD RIVER  
CONTROL  
COMPLEX**  
313

**BATON ROUGE**  
228

**NEW ORLEANS**  
102

**Bottleneck**

**MORGAN CITY**

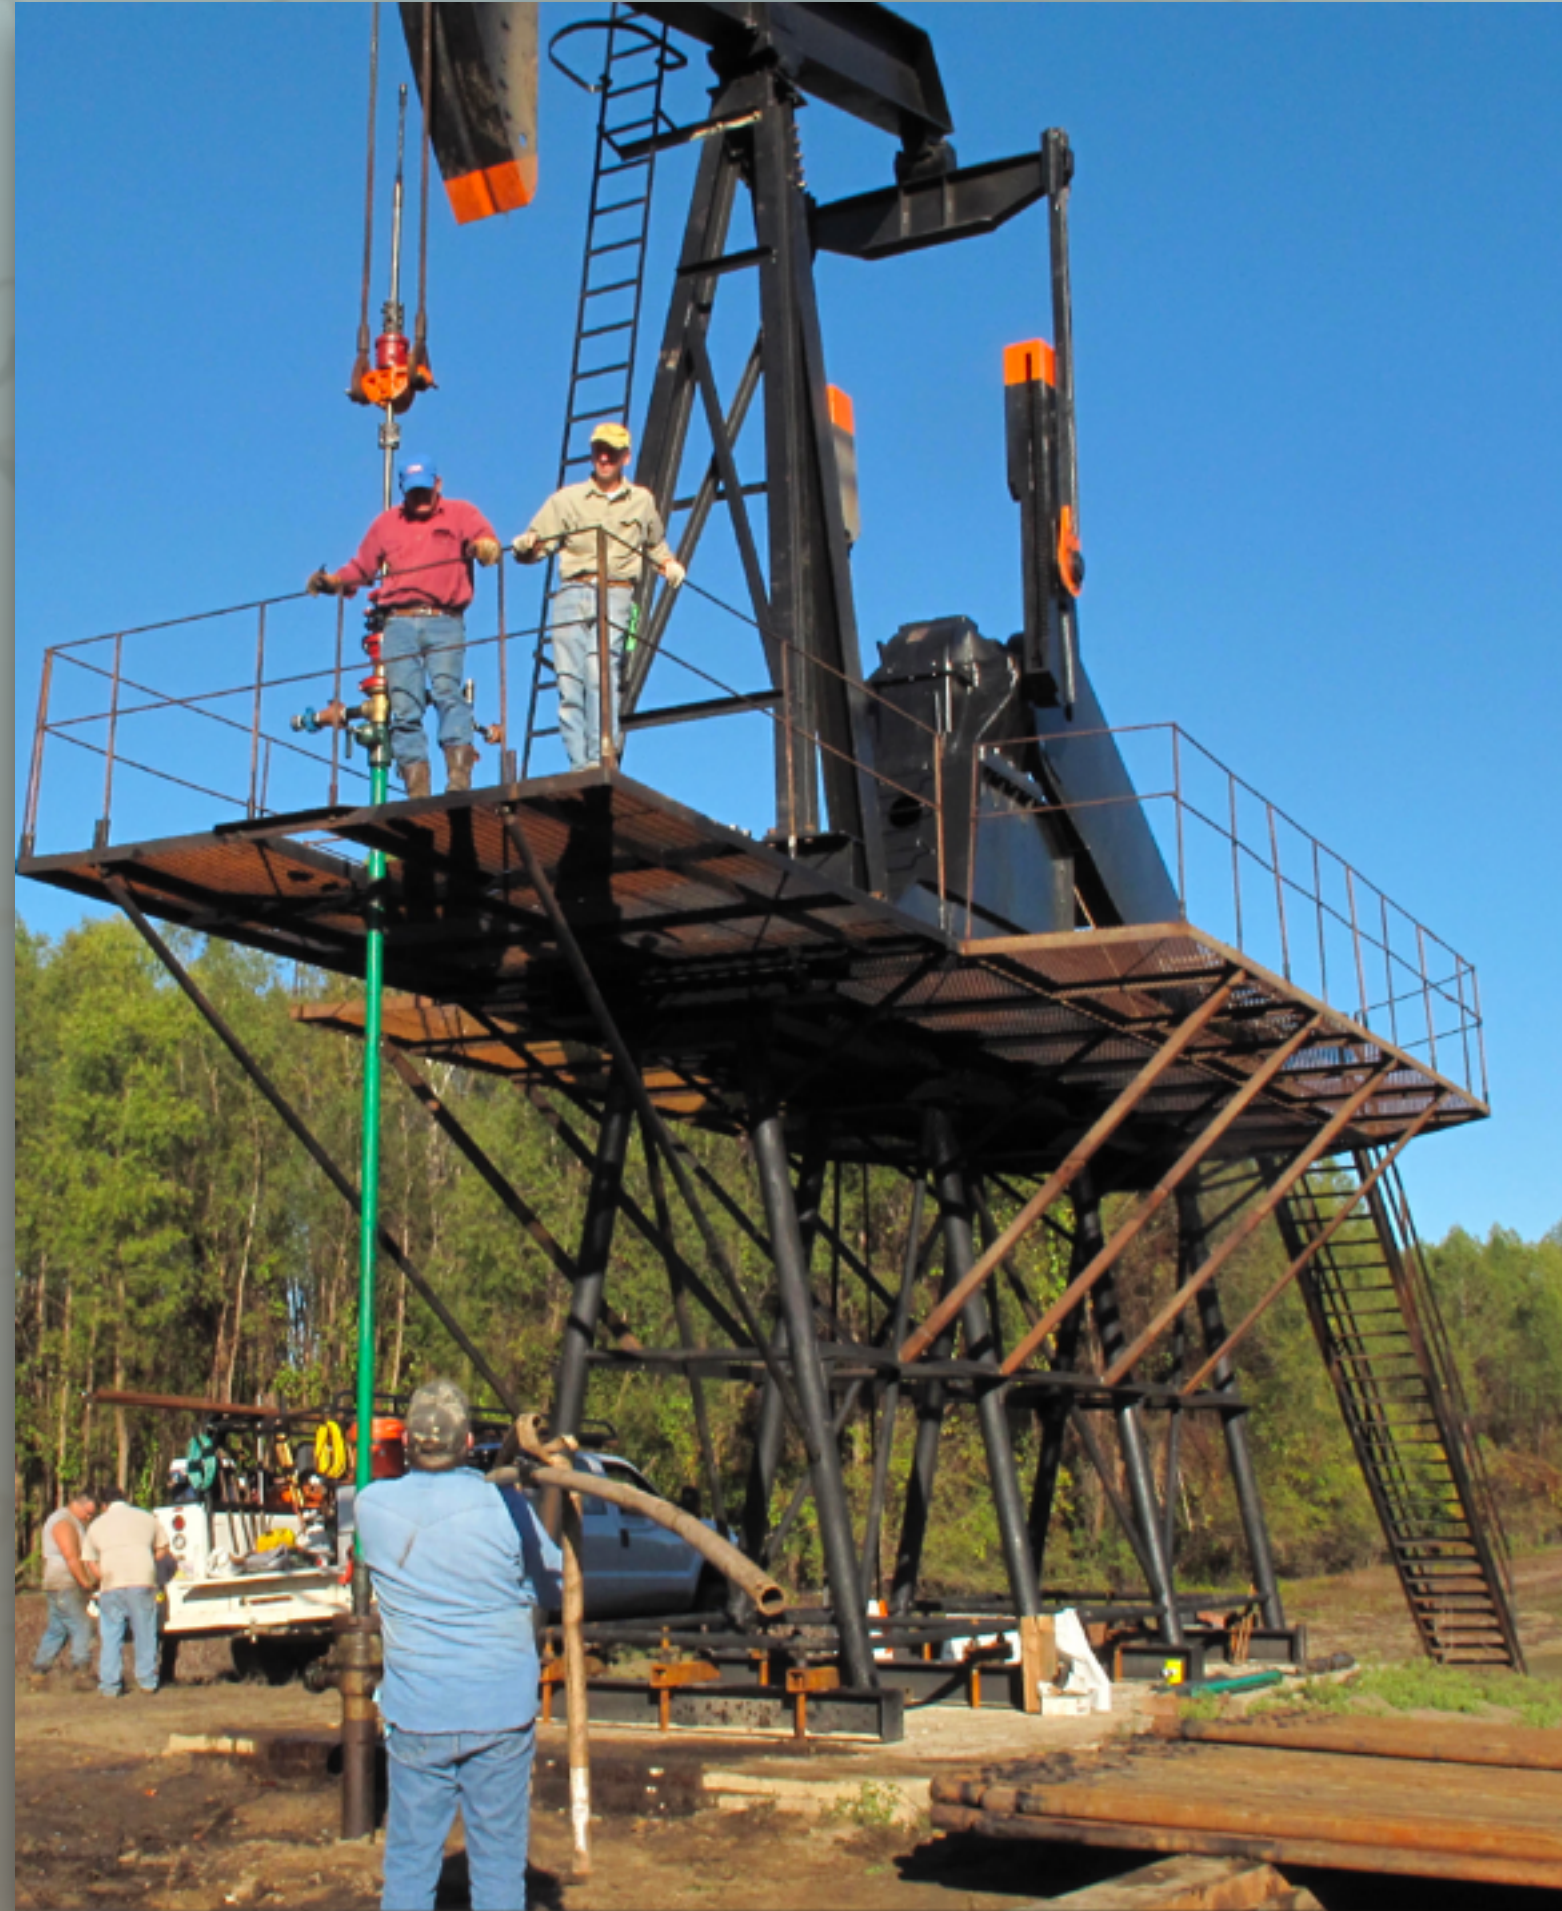
**December 2, 2011**

# Lake Mary Drilling Platforms

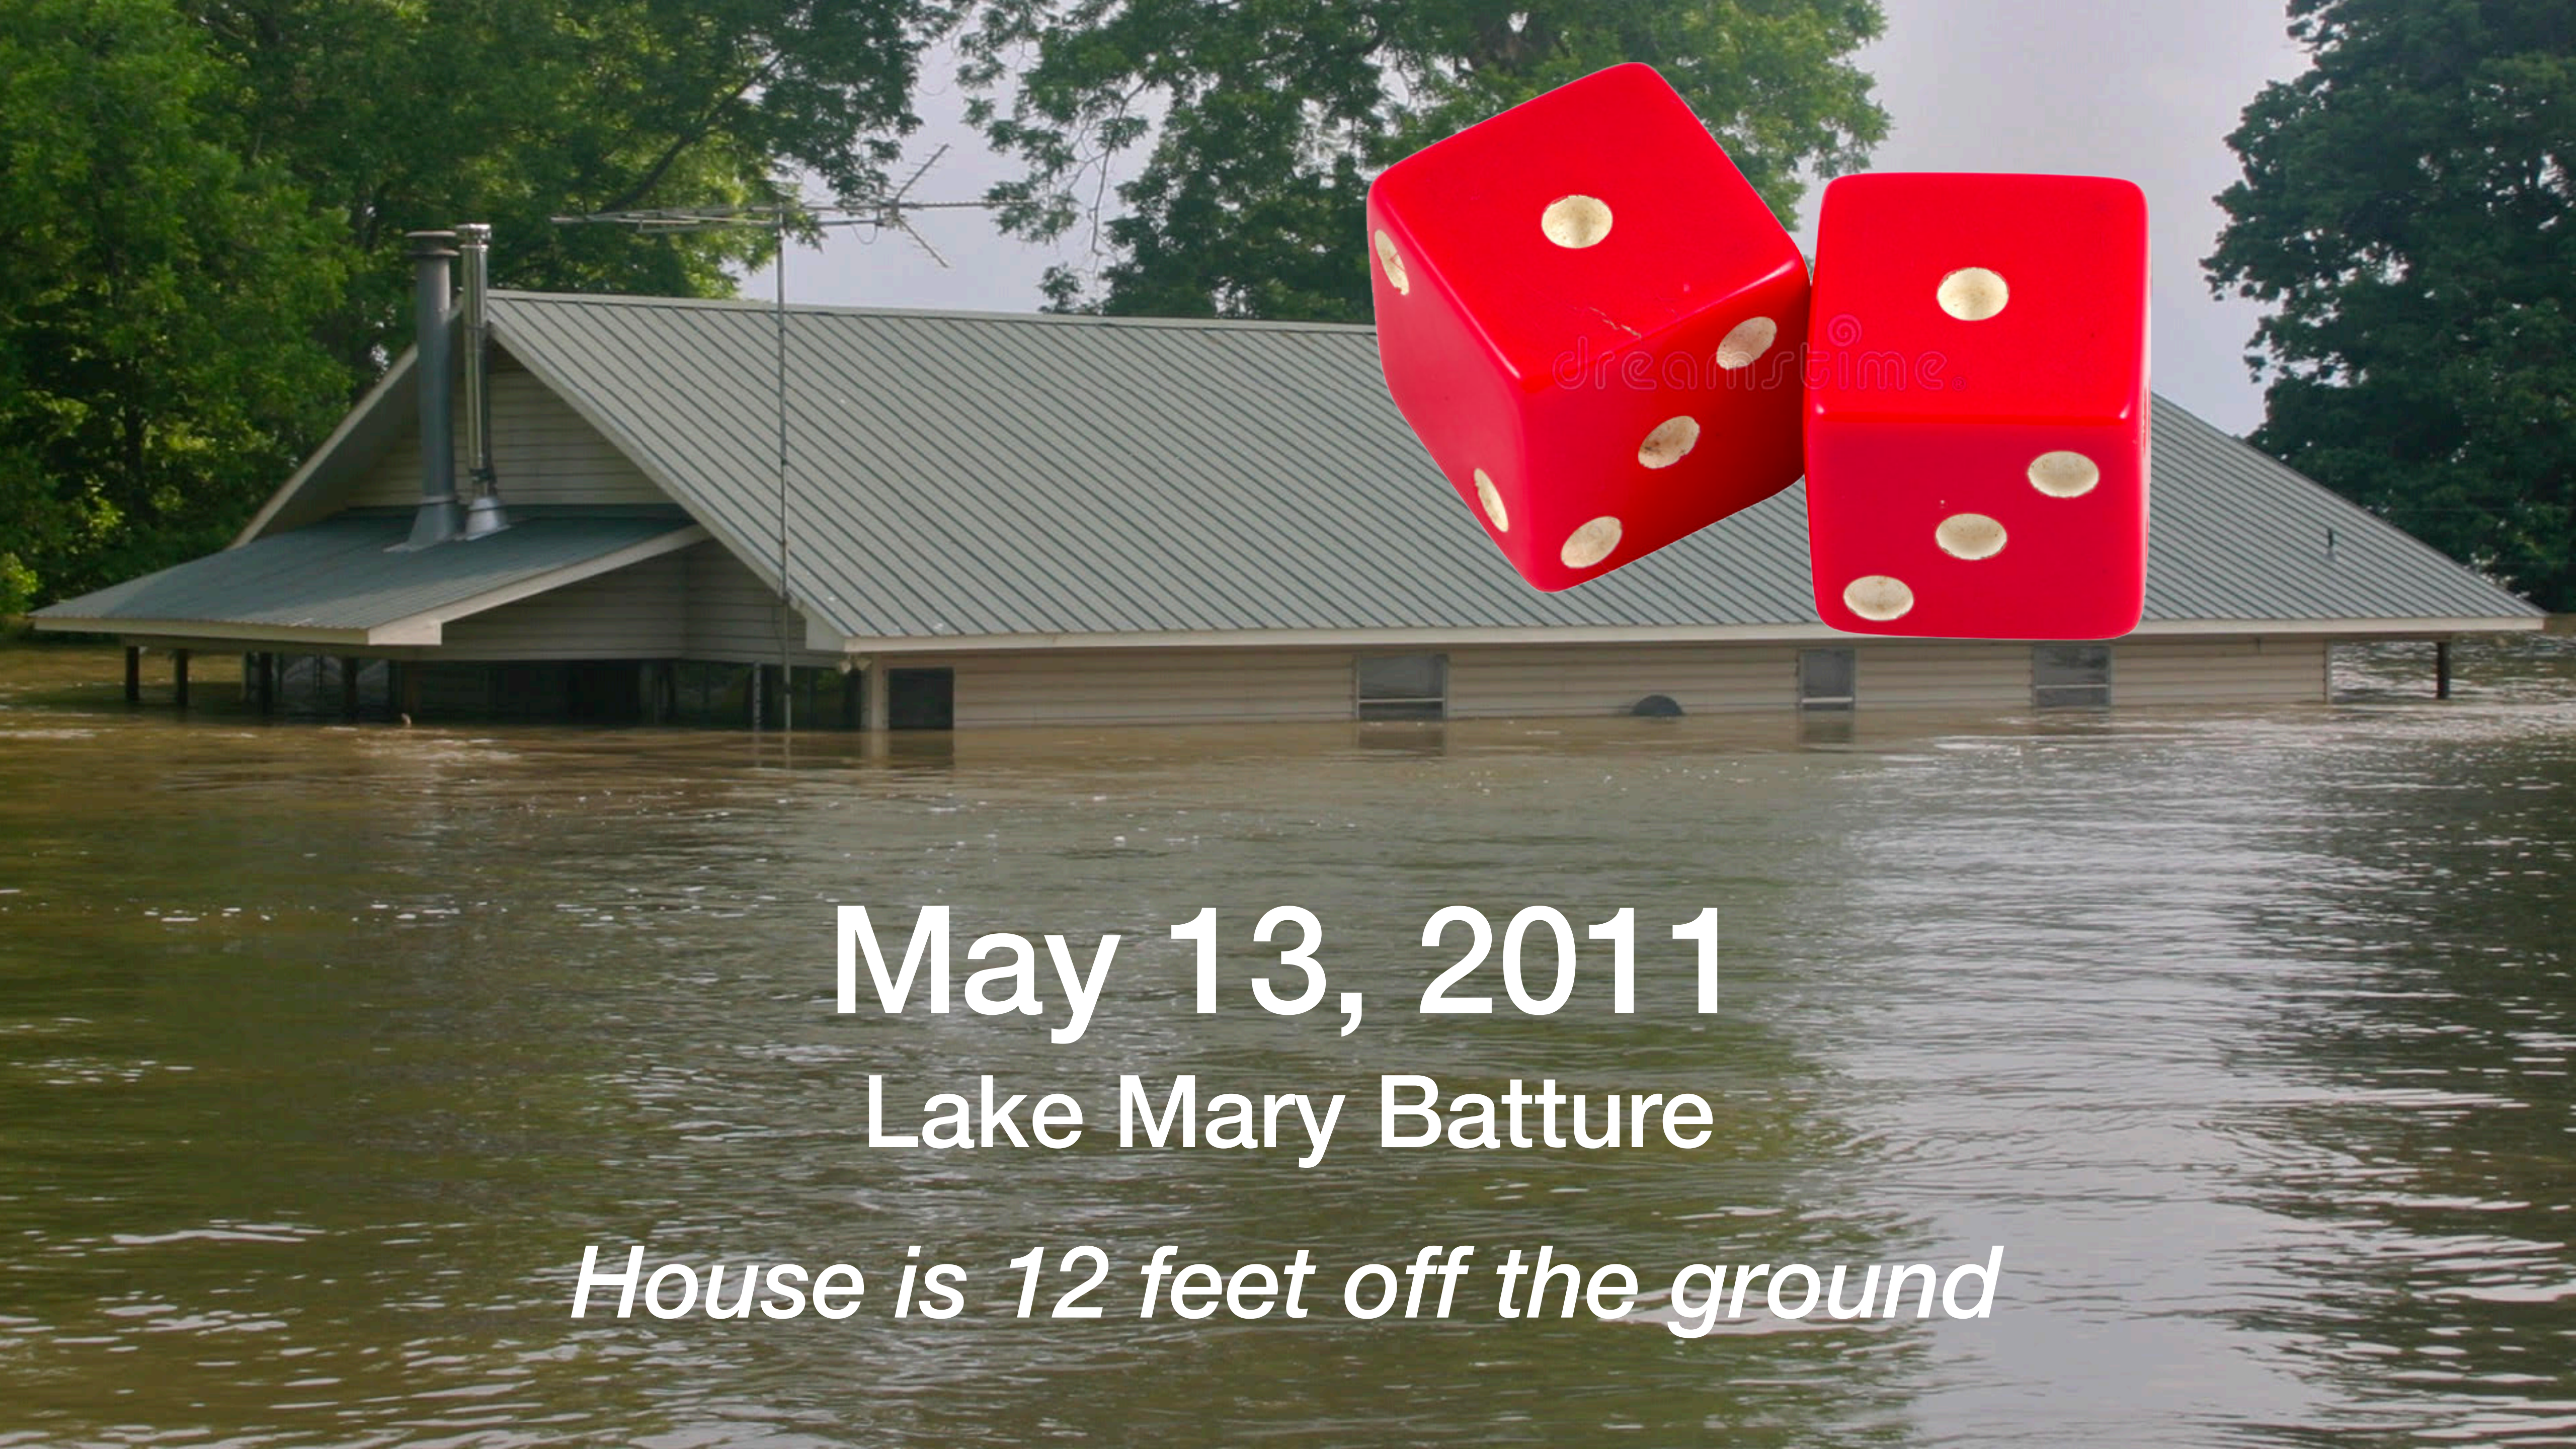
May 13, 2011

Lake Mary Batture

*House is 12 feet off the ground*

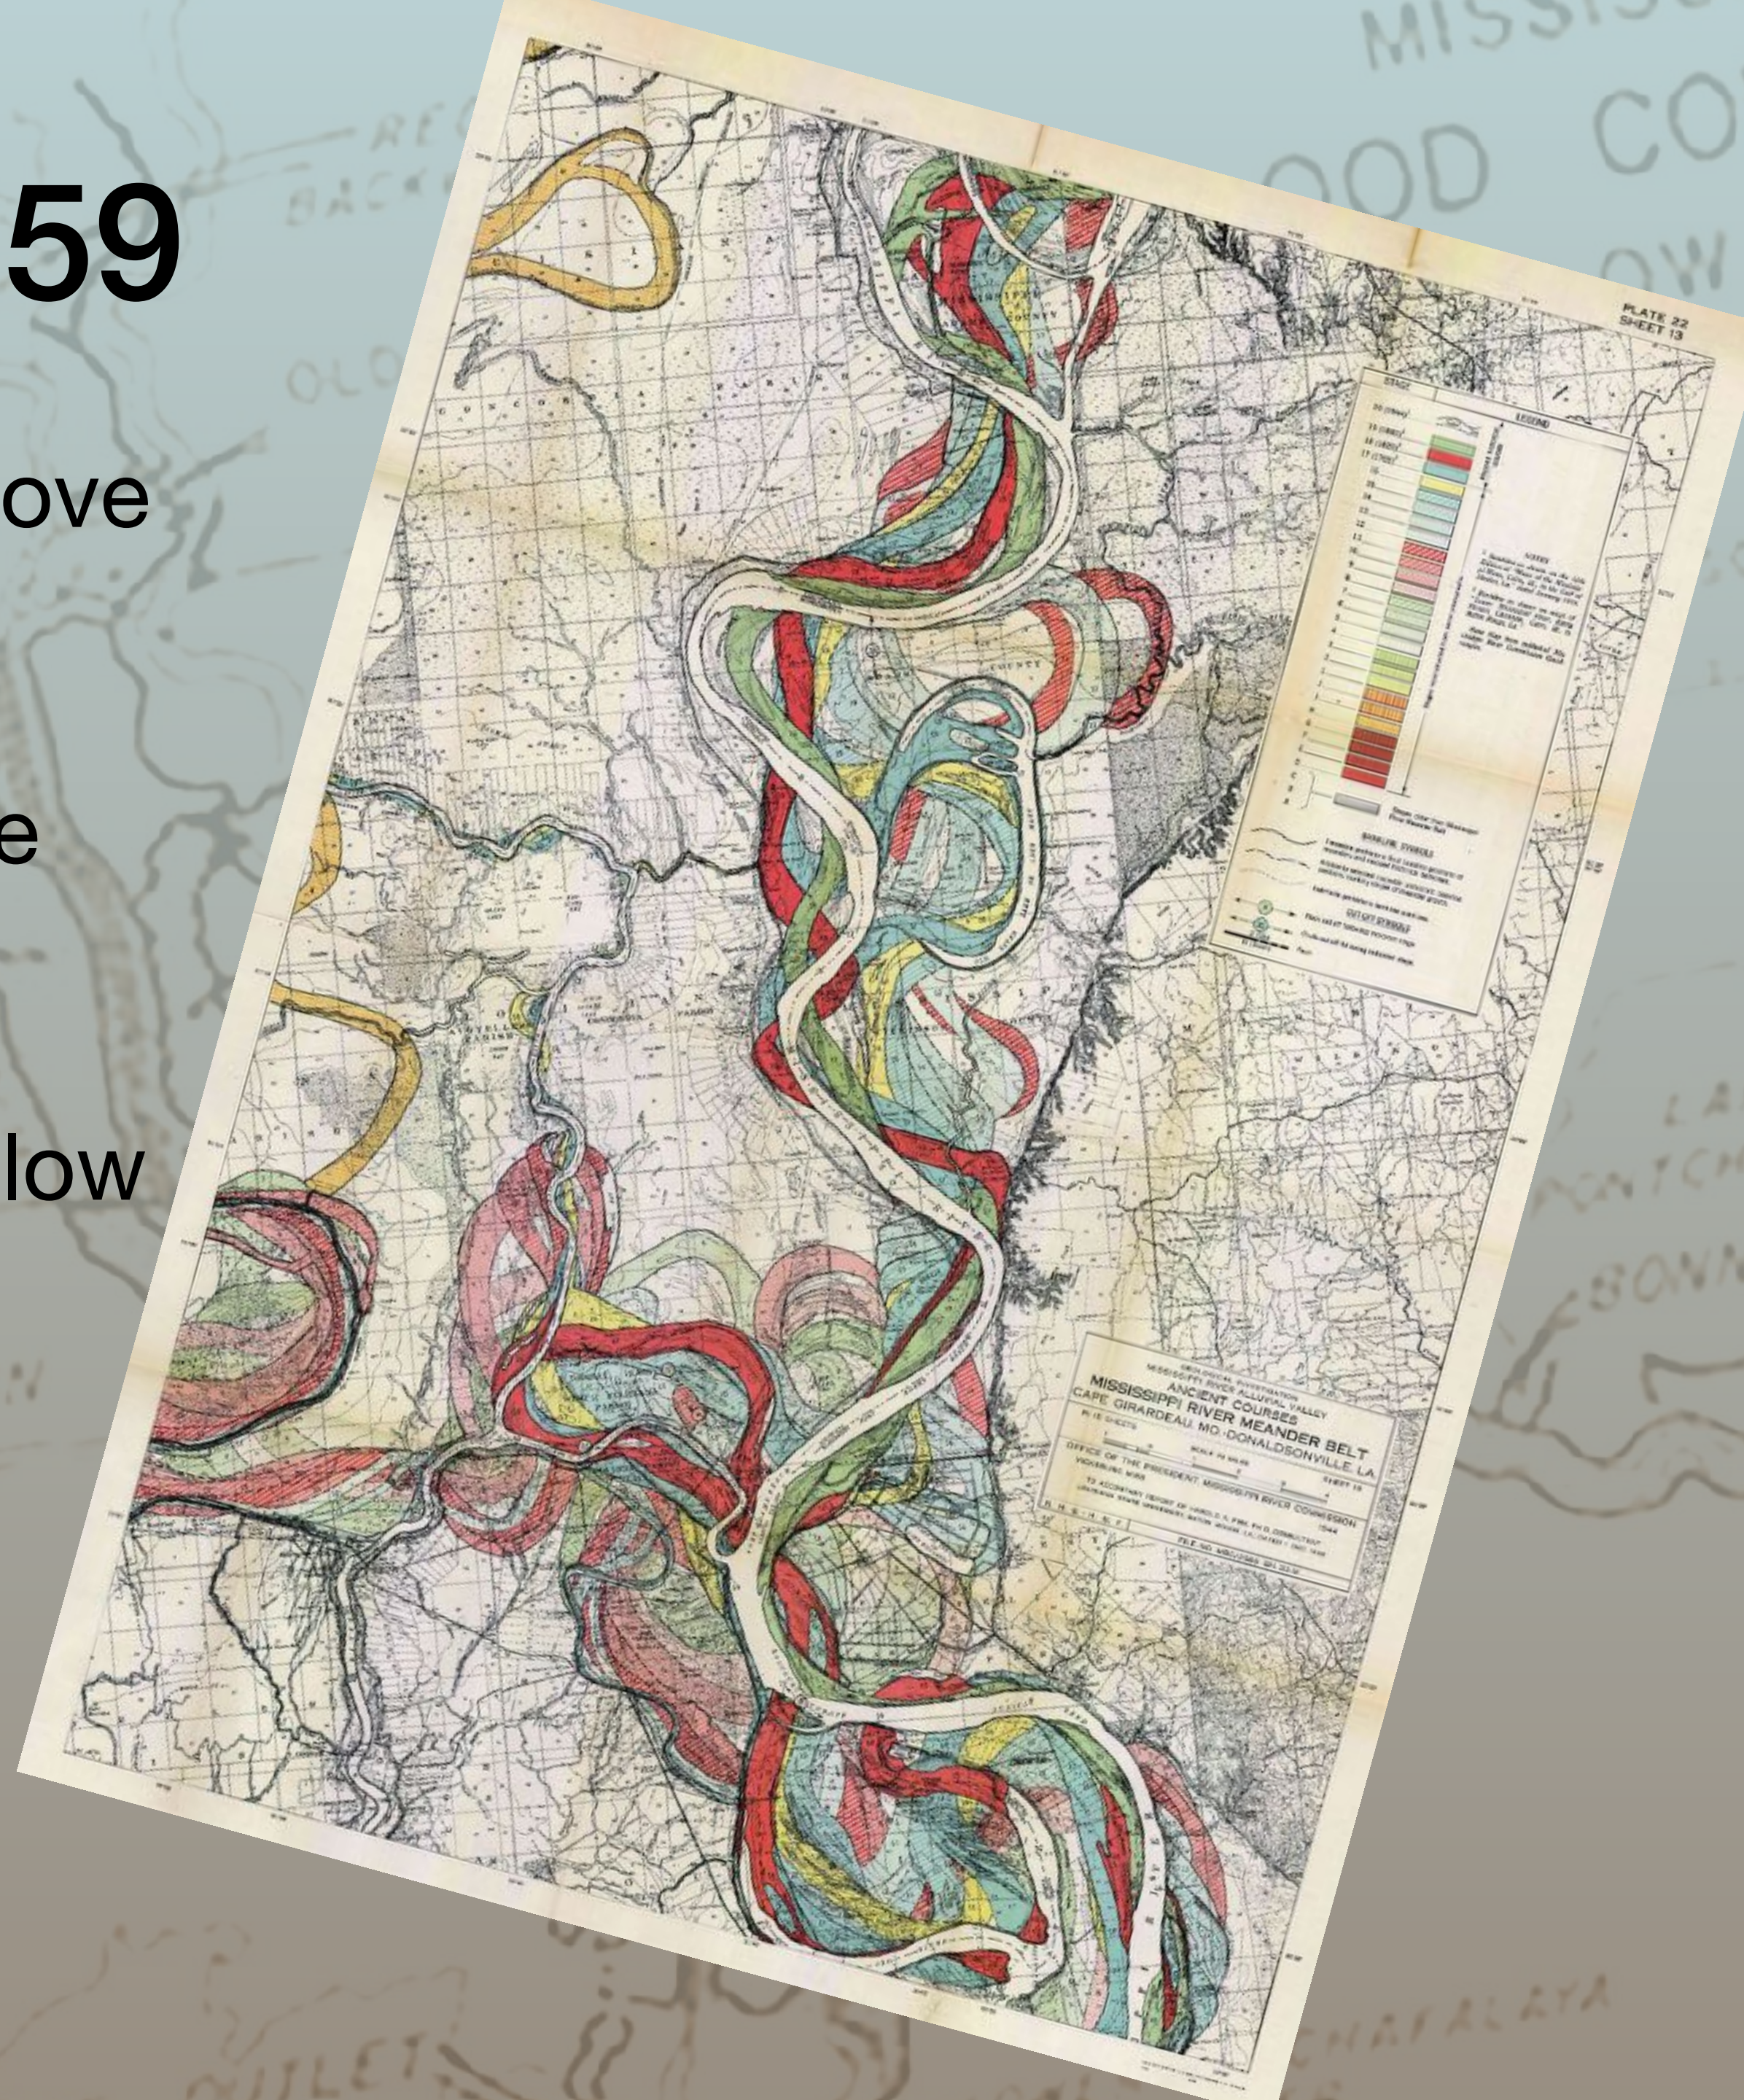
# 2008-2017

- 8 of 10 yrs above flood stage
- 388 days above flood stage
- 14.9 ft median low stage

The channel  
below  
ORCC has  
clogged up
